ADVISORY CIRCULAR 43-16A

AVIATION MAINTENANCE ALERTS

ALERT
NUMBER
268

NOVEMBER
2000

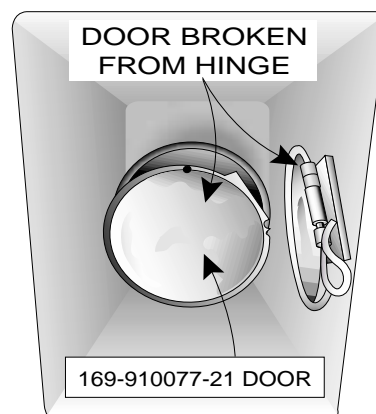
Beech; Model C-24R; Musketeer; In-Flight Engine Power Degradation; ATA 7160

During an instructional flight, the engine performance deteriorated and the pilot made an immediate landing.

A technician conducted an operational test and discovered the engine did not develop full power. After the test, he removed the air filter element and discovered the alternate air door (P/N 169-910077-21) broke loose from its hinge. The alternate air door plate lodged in the fuel servo intake and obstructed airflow to the induction system.

(Refer to the following illustration.) This aircraft had undergone a scheduled inspection 81 operating hours prior to this occurrence and the technician did not record any defects.

The submitter recommended the manufacturer consider redesigning the alternate air door to make it more structurally substantial and/or provide a means of preventing the door from obstructing the induction system airflow.

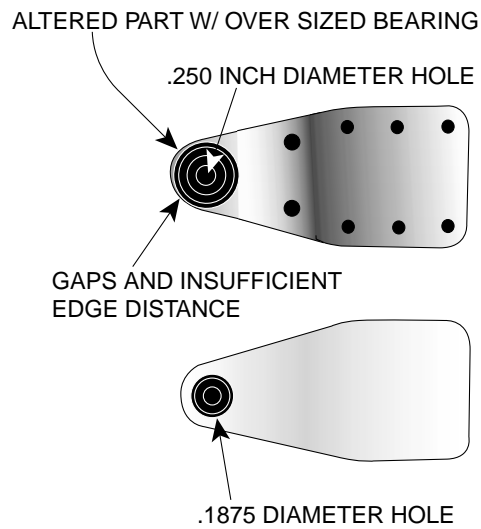
Beech; Model BE58; Baron; Improper Elevator Hinge Repair; ATA 5520

While performing other maintenance, a technician discovered an improper elevator hinge repair.

The left outboard elevator hinge point bearing did not appear correct and prompted the technician to investigate further. He discovered the wrong bearing (P/N MKSP4A) installed instead of the correct part (P/N KSP3L). The incorrect bearing has a larger outside diameter, and the center pivot fastener hole is .250 inch as opposed to an .1875-inch center hole of the correct bearing. (Refer to the following illustration.) In order to return the aircraft to an airworthy condition, he replaced the entire hinge assembly.

The previous installer ground out the hinge bracket (P/N 96-610024-601) to accommodate the larger diameter bearing. The hinge displayed gouges and scars apparently made when the installer hammered the hinge into position. The removal of hinge bracket material left very little edge distance for retaining the bearing. The .1875-inch center pivot bolt had additional spacers installed and was over torqued in an effort to compensate for the .250-inch hole. The overall workmanship of this repair was very poor. This aircraft was recently painted, and the submitter speculated a noncertificated person accomplished the improper repair.

In-flight failure of this hinge assembly could cause elevator flutter and possibly elevator separation. In this case, the technician's sharp eye may have prevented a serious aircraft accident. He cautioned maintenance personnel to inspect the entire aircraft very closely after painting, especially the flight control systems.

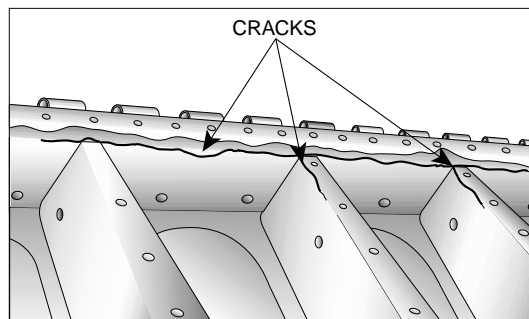
Cessna; Model 425; Conquest; Elevator Trim Tab Structural Defect; ATA 5513

While conducting a scheduled inspection, the inspector noticed a slight buckling in the area of the elevator trim tab hinge.

After removing the elevator upper skin adjacent to the trim tab hinge, the technician discovered a severe structural crack which jeopardized the trim tab security. The crack was located on the elevator hinge bracket (P/N 5834120-6) and traveled approximately 12.25 inches between two elevator ribs (P/N's 5834110-90 and 5834110-98). He also found smaller cracks in the upper radii at the aft end of the elevator ribs. (Refer to the following illustration.) He obtained a repair scheme from an FAA Designated Engineering Representative (DER).

Since only a slight ripple in the hinge area evidenced this defect, it could easily be overlooked. The submitter suggested investigating any anomaly in this area.

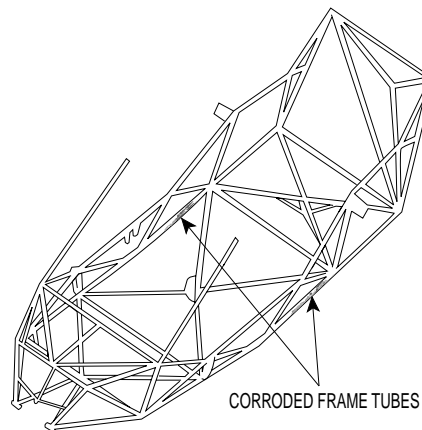
Piper; Model PA 23-250; Aztec; Fuselage Structural Corrosion; ATA 5311

During a scheduled inspection, the inspector found severe fuselage structural corrosion.

The technician replaced the left and right lower fuselage mainframe tubes (P/N 17134-44) due to the corrosion damage. (Refer to the following illustration.) He stated this damage was caused by water soaked insulation material being held in contact with the structural tubes. Also, he suspected the water came from poorly fitting door and window installations. These tubes are constructed of 1-inch diameter 4130 steel tube stock with a .049-inch wall thickness and are 62 inches long.

The submitter suggested giving special attention to this area during scheduled inspections. He also suggested making sure all windows and doors are sealed and fit properly.

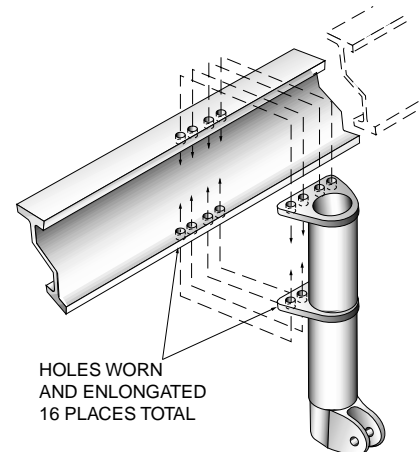
Piper; Model PA 28-151; Warrior; Main Landing Gear Attachment Defect; ATA 3211

On several occasions during scheduled inspections, the technician found the left main landing gear attachment defective.

The technician usually found one of the spar cap attachment bolts broken. The fastener holes in both the upper and lower spar caps and the landing gear strut (P/N 65319-004) were elongated. (Refer to the following illustration.) The manufacturer does not provide a repair scheme for this damage, and it was necessary to obtain repair procedures from a Designated Engineering Representative (DER).

The life of this aircraft was dedicated to flight training, and the submitter stated it was common to make a tight left turn of 180 degrees while approaching the assigned parking place. He speculated this might induce excessive stress on the left main gear attachment and result in strut attachment damage.

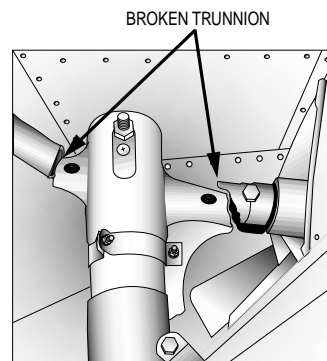
Piper; Model PA 30; Twin Comanche; Main Landing Gear Structural Failure; ATA 3211

During a landing approach, the pilot could not extend the right main landing gear. All attempts to extend the gear failed, and the pilot landed the aircraft with the gear in the "up" position.

While recovering the aircraft from the runway, a maintenance technician had to pry the right main gear out of the wheel well. When the gear was extended, he discovered the aft supporting portion of the gear trunnion (P/N 20752-09) housing broken. (Refer to the following illustration.) When the housing broke, the wheel assembly shifted and jammed in the wheel well. The submitter did not give a cause for this defect, but suggested a close check of this area during scheduled inspections.

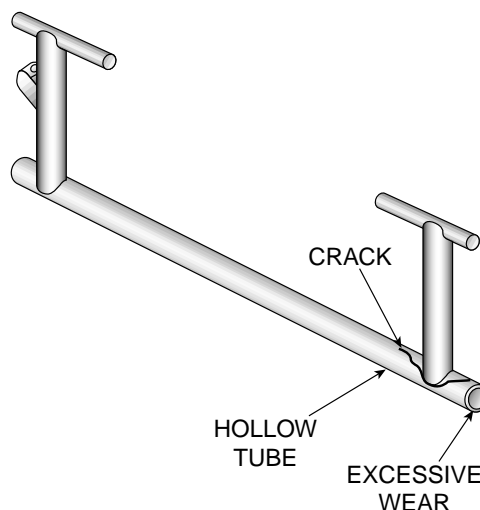
While investigating a recent aircraft incident, FAA inspector David Miller, of the Houston, Texas Flight Standards District Office, found the right rudder pedal broken.

The failure resulted from pre-existing cracks where the torque tube and rudder pedal attach. The inspector found excessive wear on the torque tube where the "Nylon" bearing rotates. (Refer to the following illustration.) After inspecting the rudder pedal torque tube, Skystar determined the excessive wear resulted from an installation error. Part of the torque tube structure was removed, presumably to make the bearing installation easier.

This article is intended to notify operators of affected aircraft models manufactured prior to September 1995, that a hazardous flight safety condition may exist if the aircraft is not in compliance with the inspection requirements, kit, and instructions referenced in the SL 47. Skystar stated an estimated 2,000 Models 1 through 4 aircraft rudder pedal installations may be affected, and 10 cases involving rudder pedal cracks have been reported. In some of these cases, failures occurred at a relatively low number of operating hours.

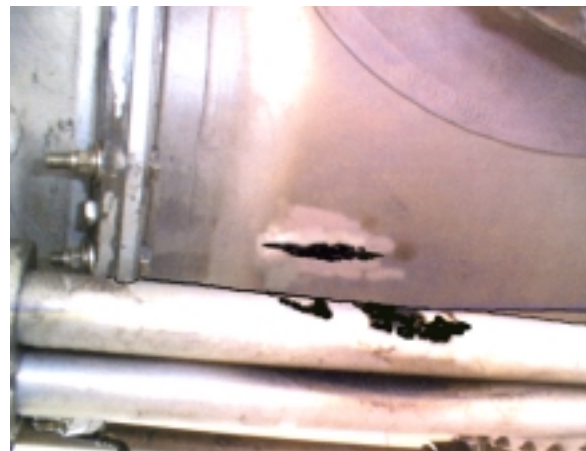
During a scheduled inspection, a maintenance technician discovered a hole in the engine case.

The hole in the power section case allowed hot engine gases to escape which damaged external wiring and transfer tubes in the area. (Refer to the following illustration.) The available evidence indicated a lightning strike caused the hole. The submitter did not offer any information concerning powerplant operating parameters resulting from this defect.
